2025 National Environmental Achievement Awards

Community Leadership Award

Arroyo 1 Dam and Green Infrastructure Improvements

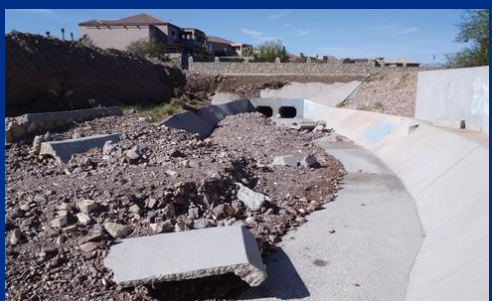
Heavy rain overwhelmed infrastructure, causing severe flooding and damage to surrounding roads.

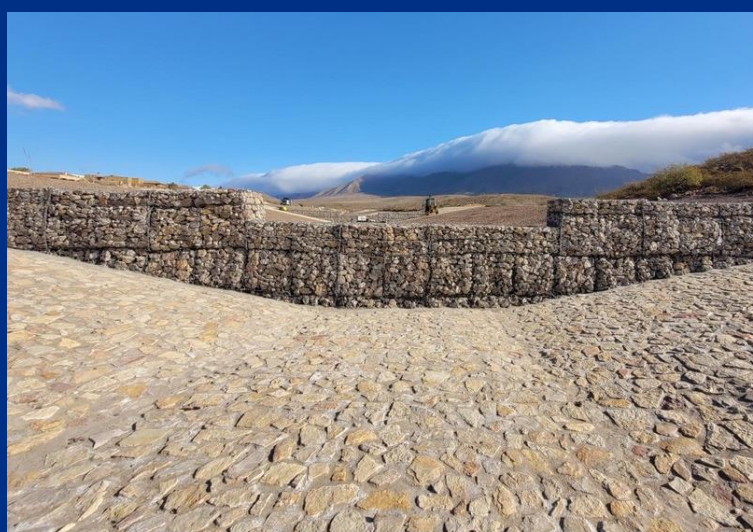
Gabion structures provide structural functions while blending into natural surroundings.

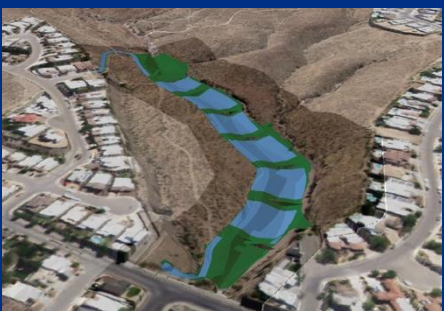
Project designed to decrease velocity of stormwater coming off the mountain.

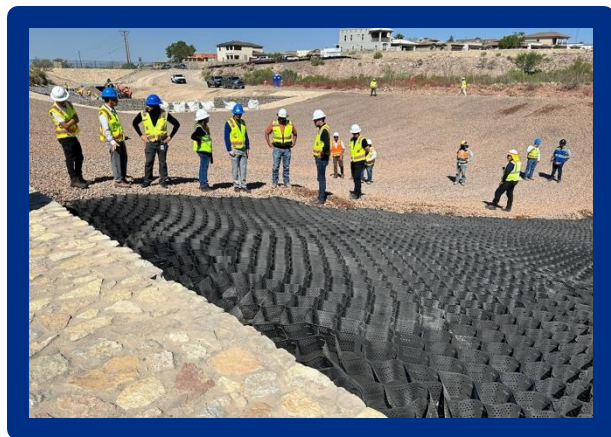
First EPWater project to utilize geogrids, a low-lying material that provides stability and prevents erosion.
